HISTORIC SANTA FE

A Fresh Face for the Pino House

A Recap of Our Summer Trades Intern's Projects

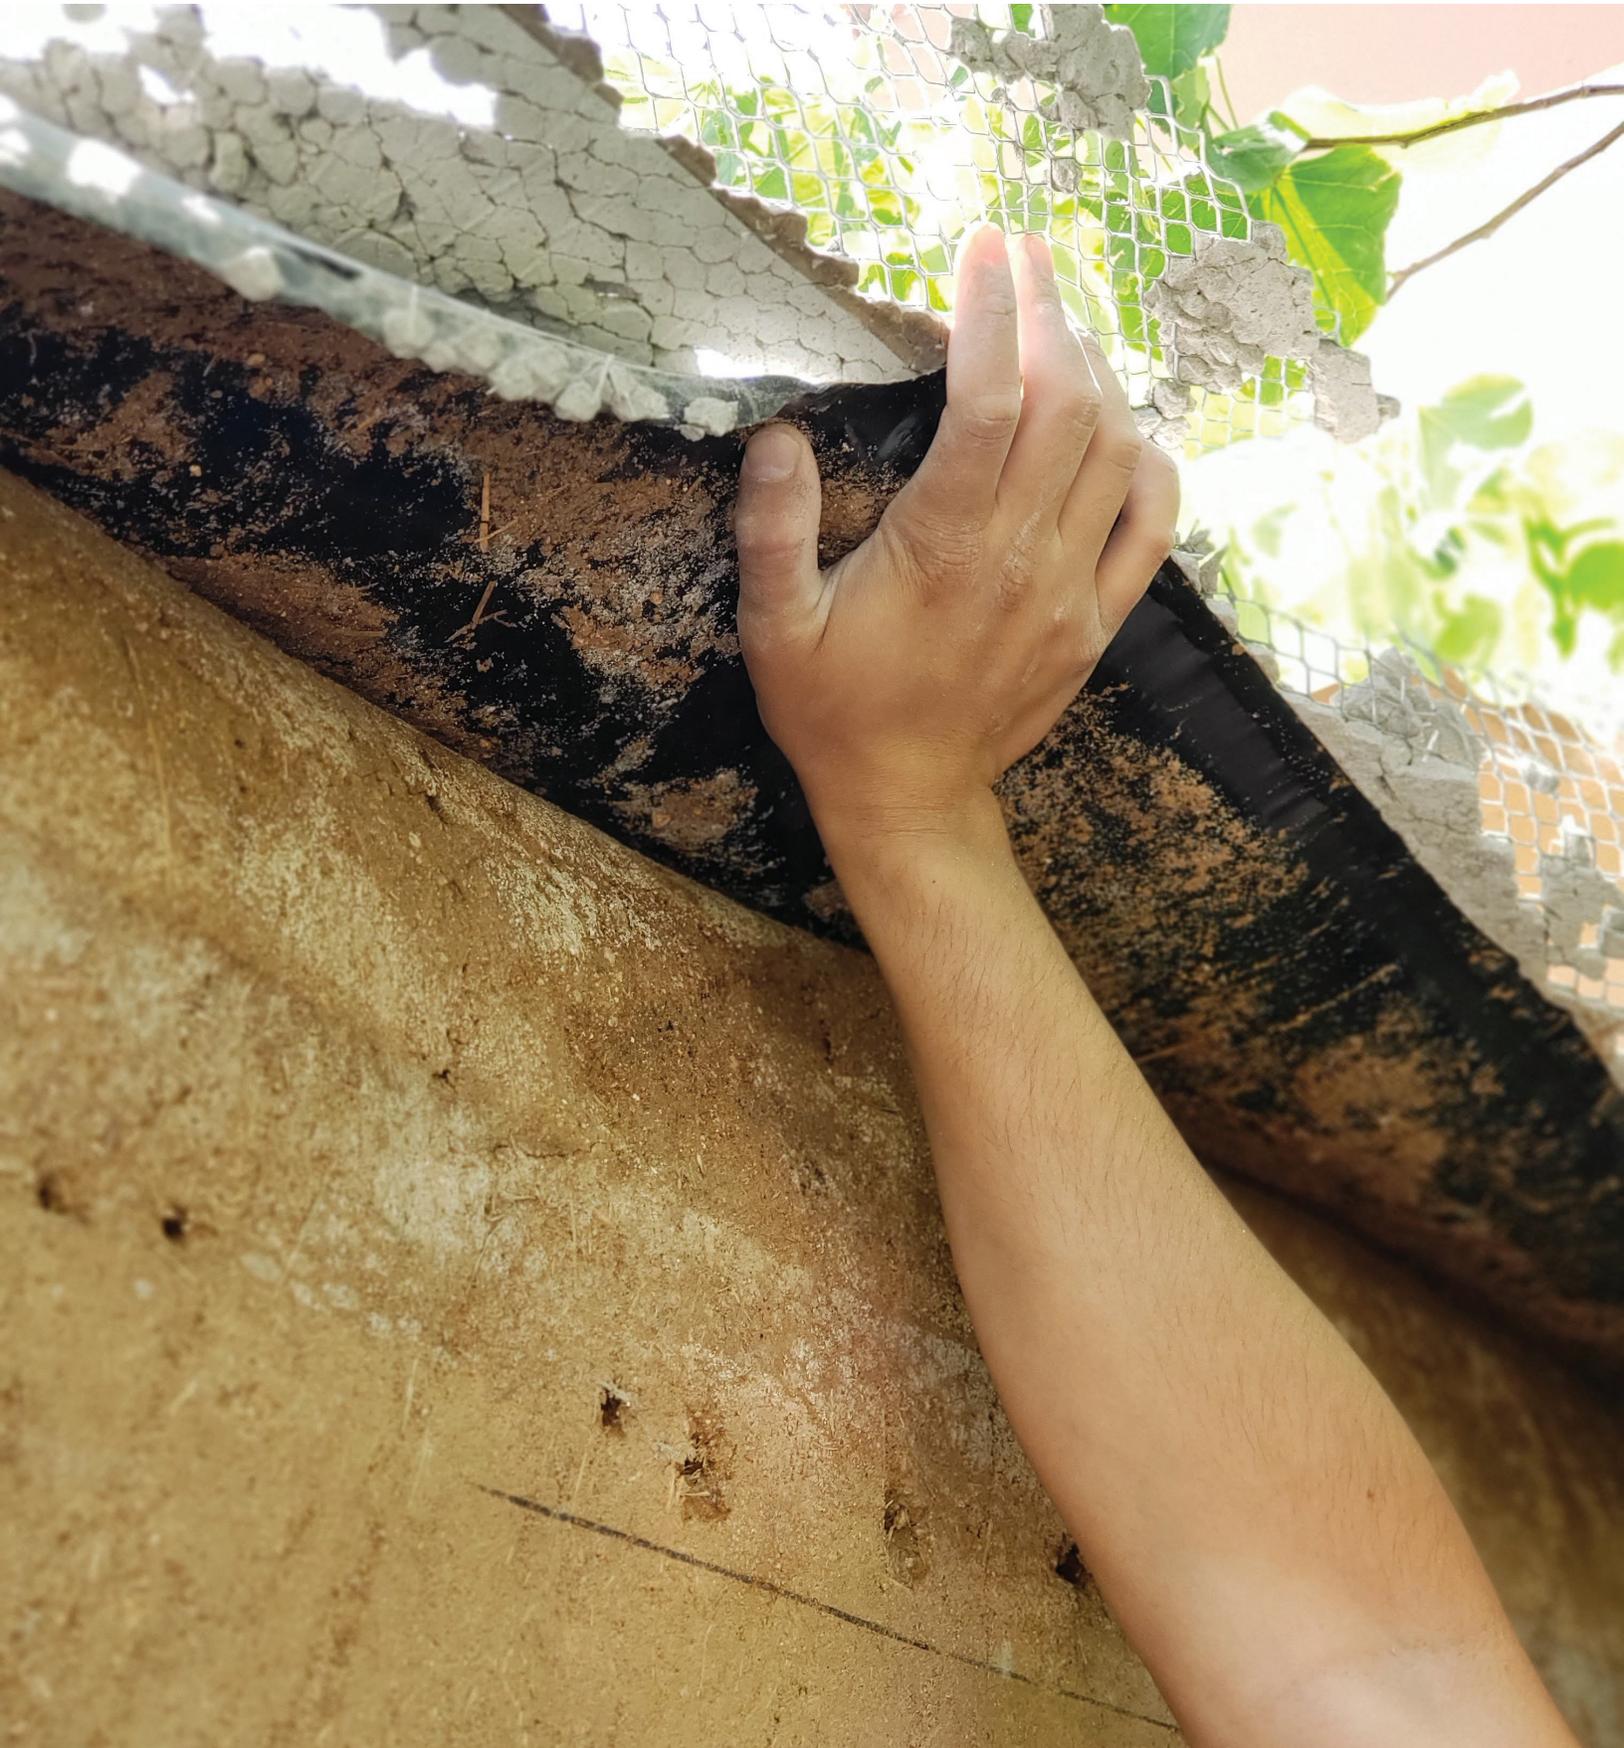
Cover photograph: Trades Intern Ramon Dorado removing stucco from an adobe wall, photo by Mara Saxer

Ramon spent the majority of his 10-week internship at Las Golondrinas, first removing the modern cement stucco, then repairing any damage to the adobes beneath it before applying a mud plaster made from local dirt dug near the site, as it would have been at the time of construction. The building is thought to have been plastered in mud or lime originally, or possibly both during different eras. He also repaired the stone foundation, repointing the mortar with a traditional lime material.

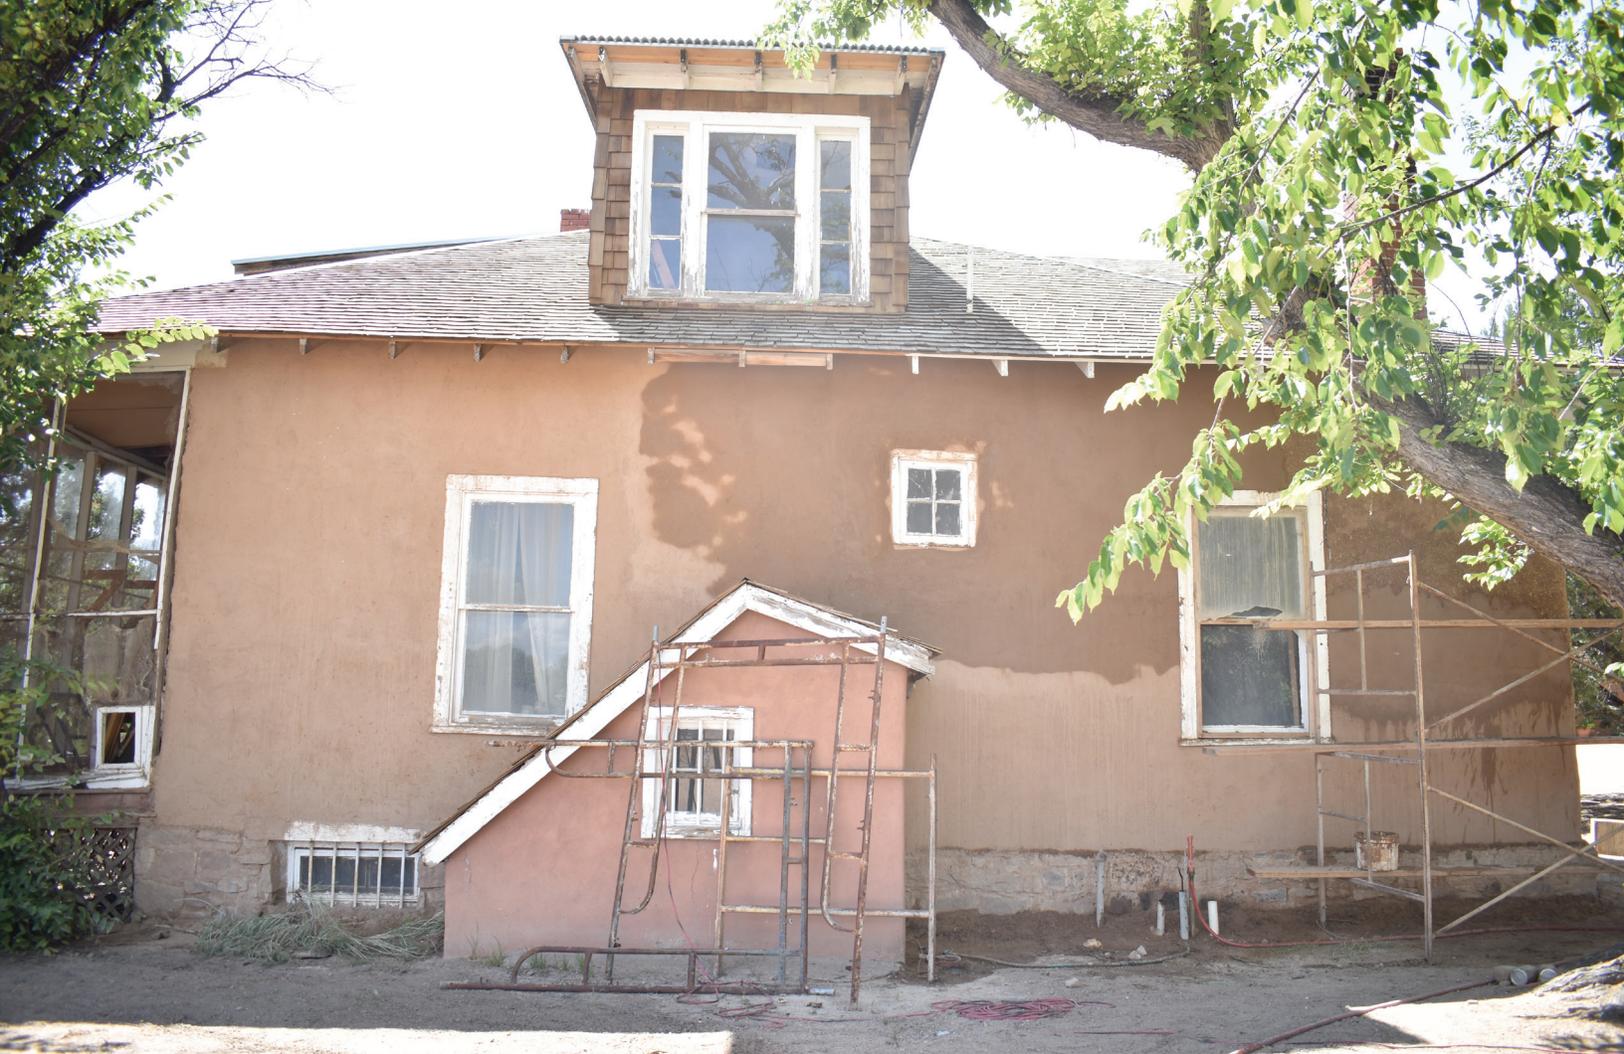
Mud plastering in progress at the Pino House, Las Golondrinas, photo by Ramon Dorado

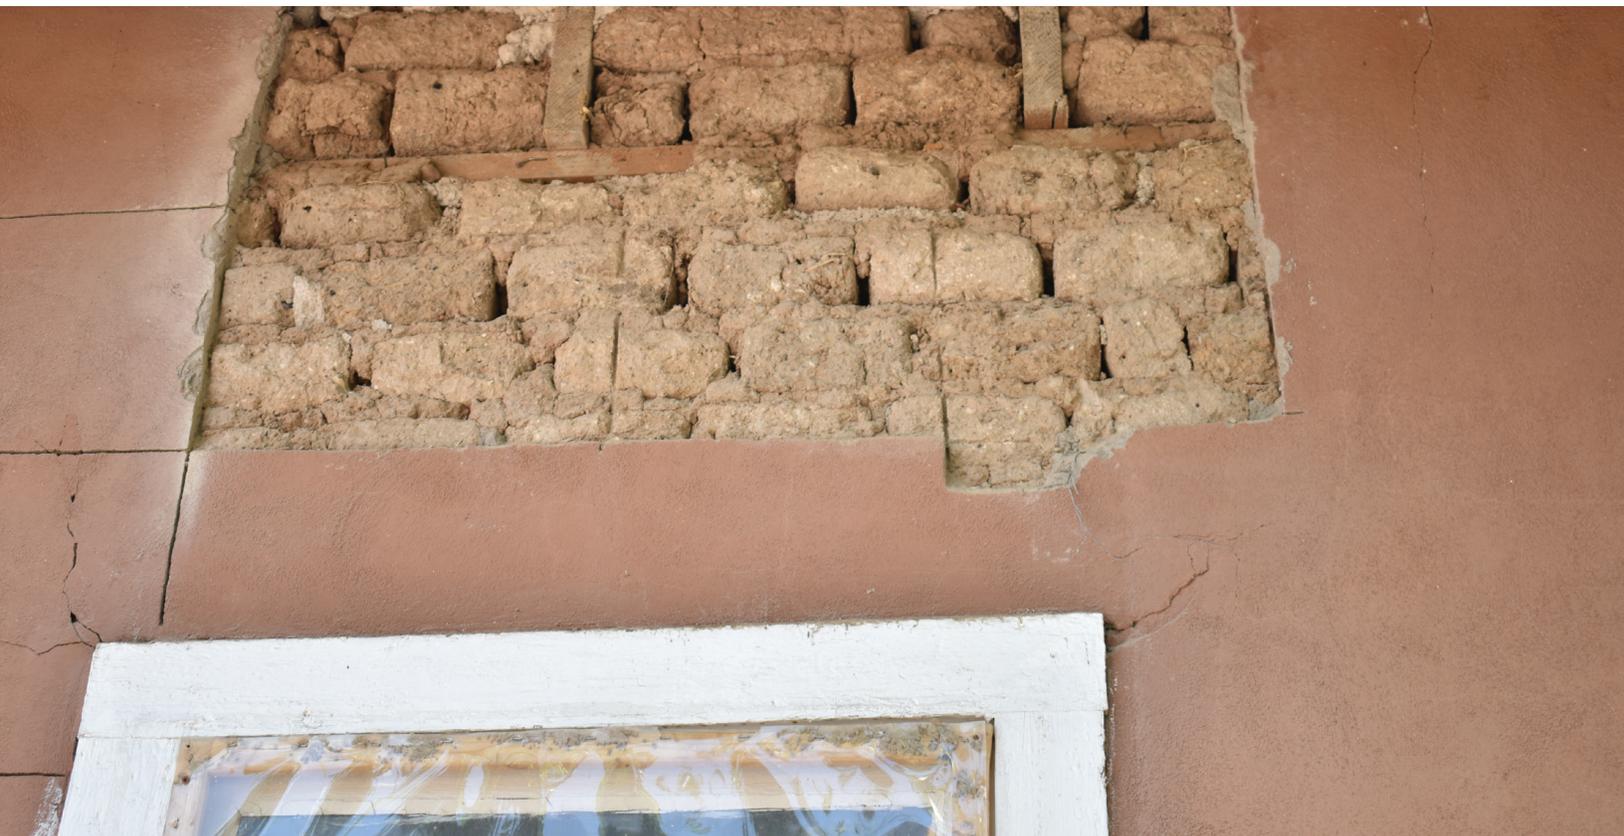
Partially removed stucco and the adobe beneath, The Pino House, photo by Ramon Dorado

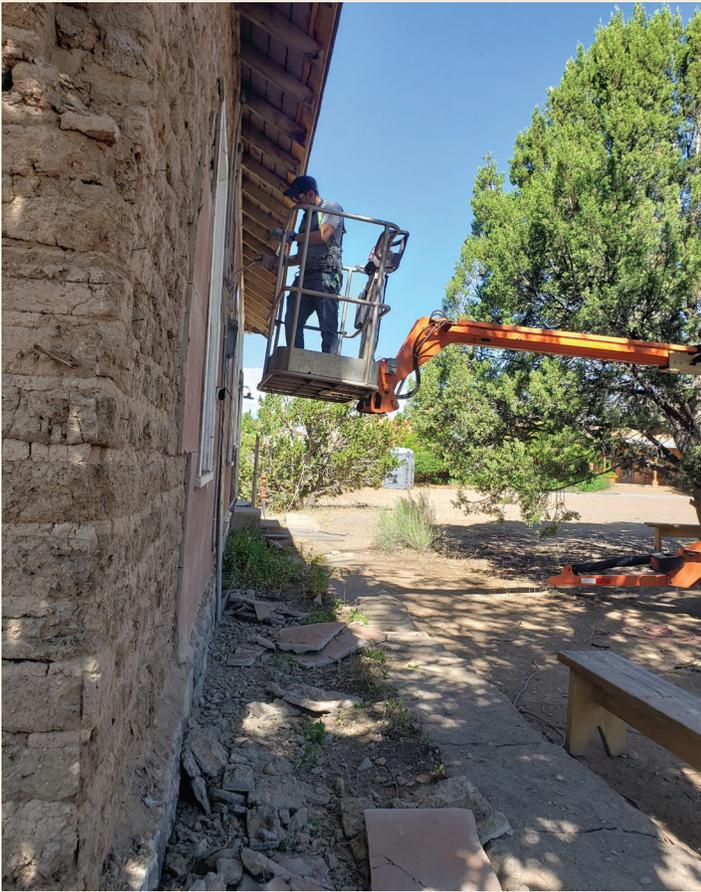
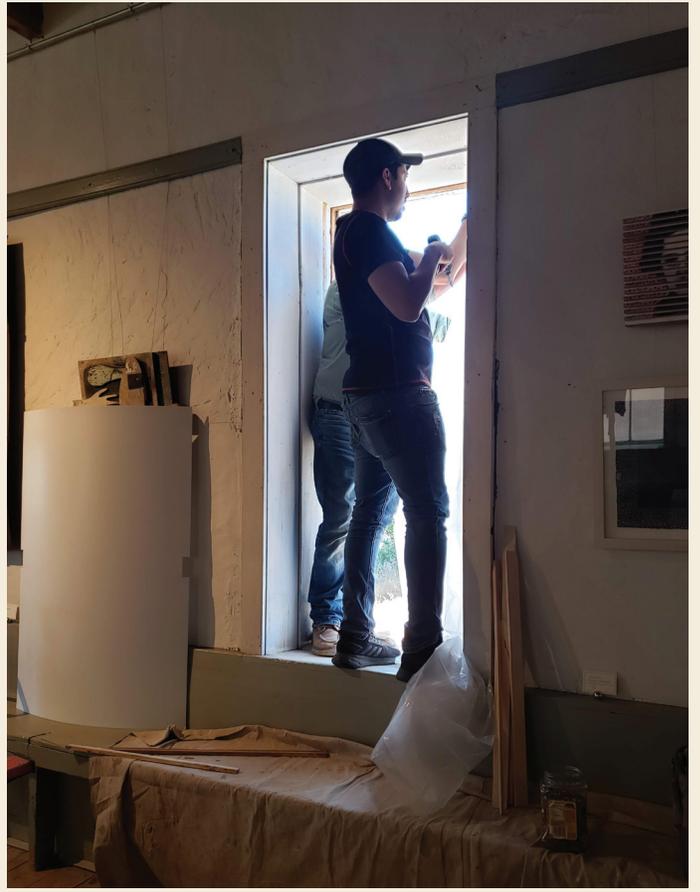
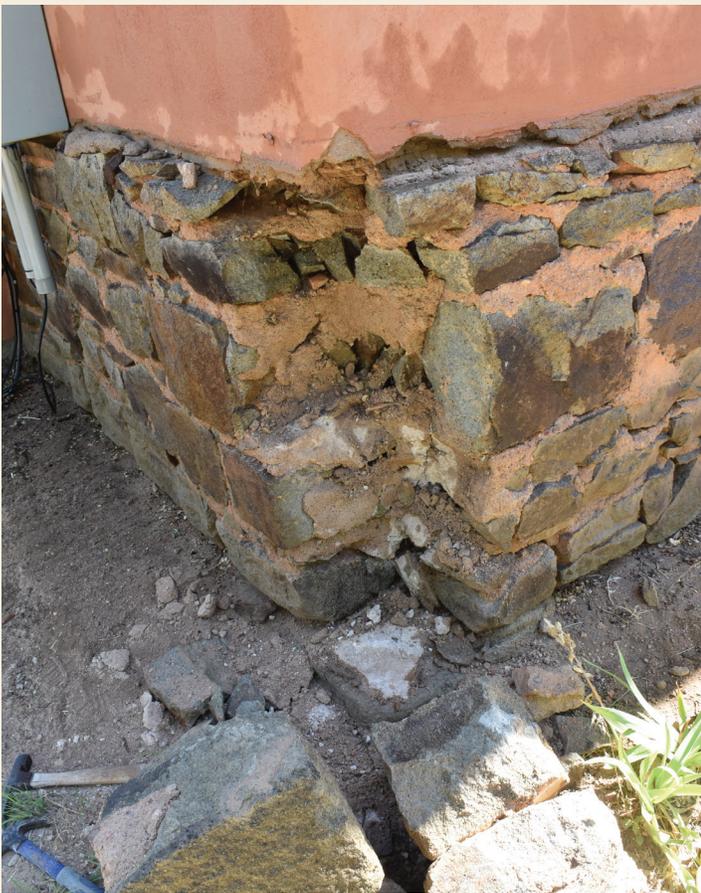
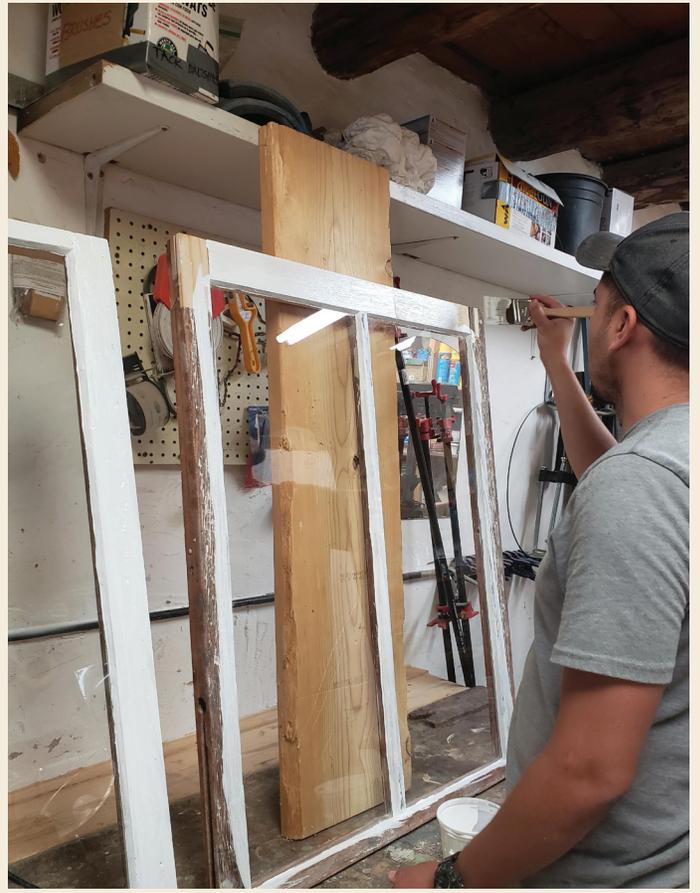
Photo captions: Page 3 (clockwise from top left): Ramon Dorado removes panels of stucco from The Pino House, photo by Mara Saxer; Ramon working on a window jamb at La Sala de San Jose, photo by Mara Saxer; In progress foundation repair at The Pino House, photo by Ramon Dorado; Ramon painting a window sash from La Sala de San Jose, Galisteo, photo by Mara Saxer.
